Limited Visual Dam Safety Inspection Summary Report

MA-086

HC&S Reservoir 81

Limited Visual Dam Safety Inspection Conducted on: 04 April 2006

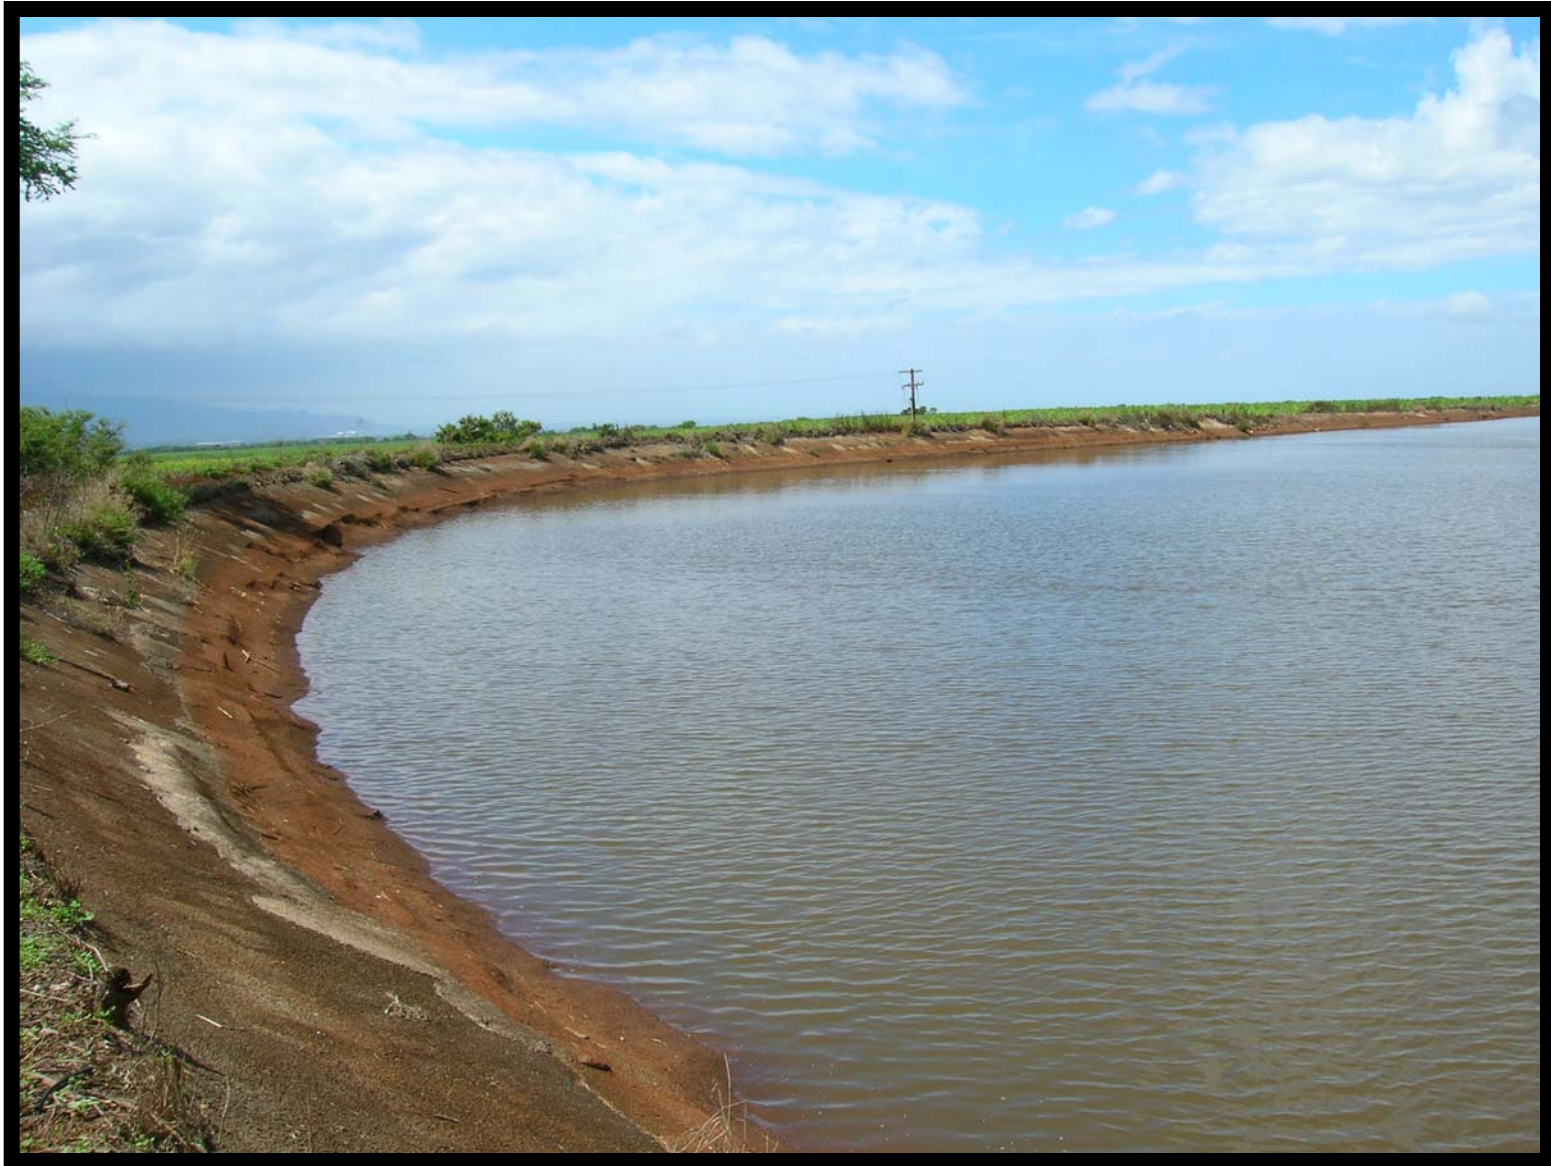
086 upstream slope

Modifications / Improvements: The concrete lining of the upstream slope has been patched in the past.

Erosion, cracks and sinkholes were not observed.

- a. The upstream slope appeared to be in satisfactory condition and requires no corrective action.

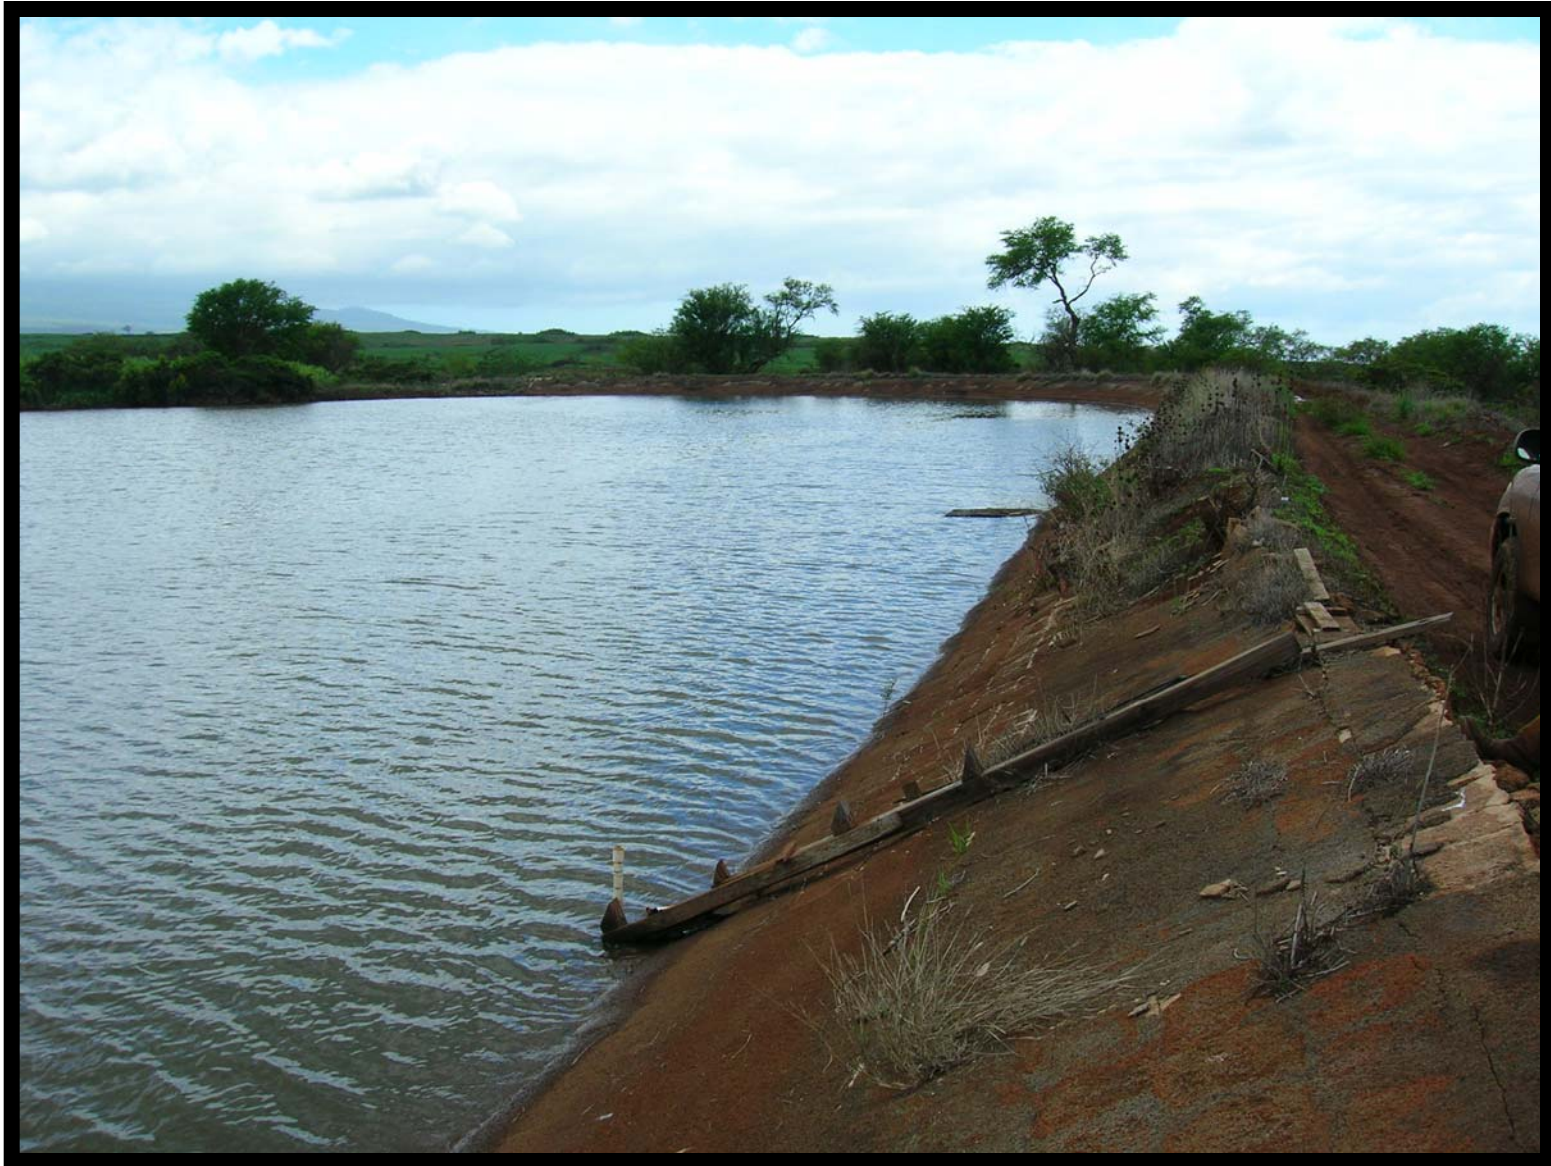
086 upstream slope and gage

A wooden staff gage was observed.
